# ANAC

## ADVERTENCIA 193/DAG

Procedimiento correcto para realizar el NIVELADO y el REGLAJE de las aeronaves Piper PA-12.

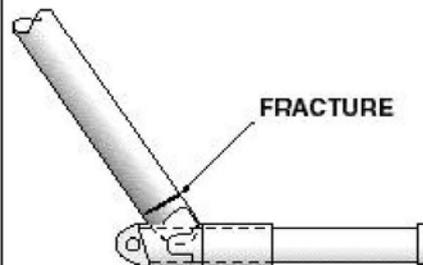
The pilot stated that during the afterlanding rollout, the left main landing gear collapsed.

An examination disclosed that the left main gear lower leg (P/N 58383) had broken. There was evidence of severe corrosion inside the bore of the lower gear leg at the point where it attached to the axle. (Refer to the following illustration.) It was speculated that approximately 70 percent of gear leg structure had been consumed by the effects of corrosion at the point of failure. It was believed the corrosion was caused by moisture and possible other contaminants entering the inner core of the gear leg through the landing gear fairing attachment bolt holes. This area is difficult to properly inspect due to the position of the gear fairing and the tie rod clevis. It was recommended this area be stripped of paint and inspected using dye penetrant to detect any cracks or pitting. It was also suggested that the strut be filled with linseed oil, allowed to soak for a time, and then drained. It would be wise to seal the landing gear fairings at the strut attachment holes.
